Galvanized steel and galvanic corrosion

Hot dip galvanizing is a well known method to protect steel against corrosion and a powerful way to increase the life time of the product when used in very corrosive environments.

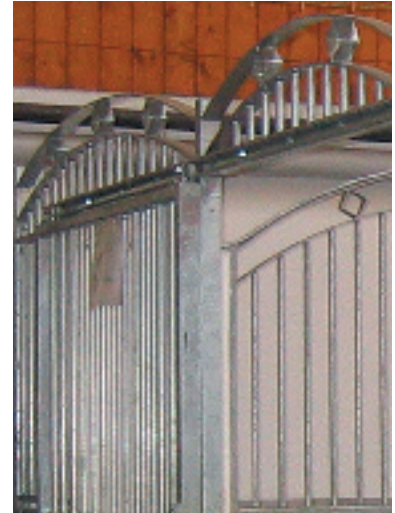
Newly galvanized steel could be very bright.

After a while in use the surface may be more dull.

Differences in colour may exist, but do not influence on the quality of the corrosion protection. The reason for the differences is that the reaction between steel and iron varies depending on type of steel and cooling speed after galvanizing.

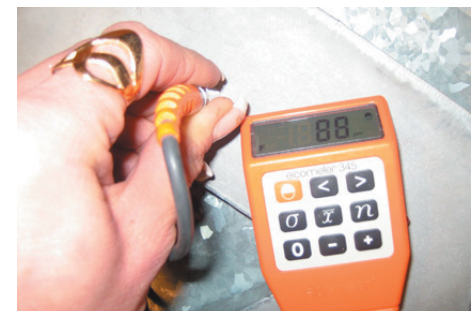
Thickness measurements and visual control of the surfaces takes place before the products leave the galvanizing plant.

Thickness measurements.

In the galvanizing standard EN ISO 1461 it is specified how samples for coating thickness control of galvanized products shall be collected.
